## Why is the audio low when my Jabra headset is connected to a Polycom VVX desk phone?

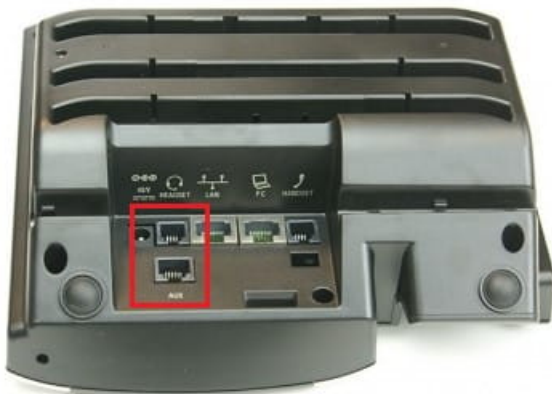
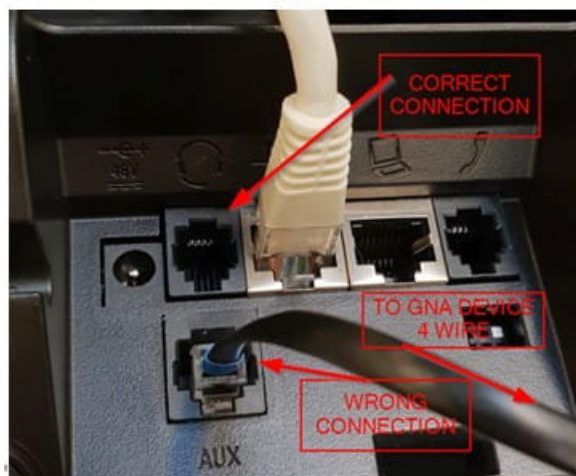
The received/transmitted audio may be low because the headset cable is connected to the wrong port on the phone. Connection to the wrong port may cause low audio or even permanent damage to the headset. Make sure the Jabra flat cord with modular connector is inserted into the headset port on the desk phone. The headset port is typically marked with a headset icon.

The following pictures of the desk phone show the location of the correct headset port, which shows a headset icon, and the incorrect AUX port.
